Kansas Department of Agriculture Technical Assistance Study

Winfield, KS

November 2021

CTP Grant No. EMK-2018-CA-00006
Project #: 8275000403

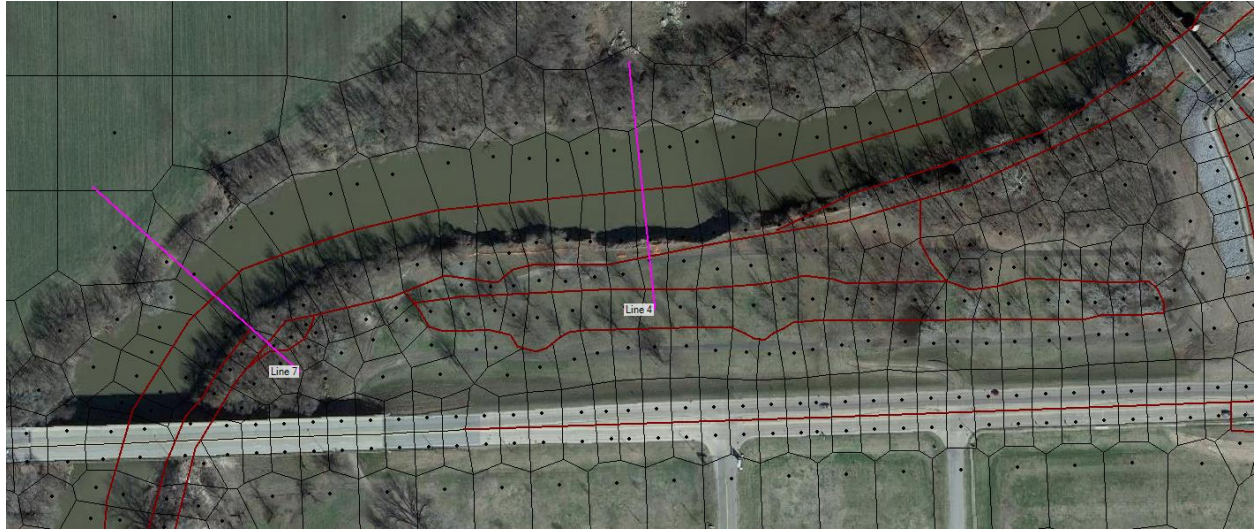
Figure 4-1: Locations of the profile lines used to evaluate the change in velocity profiles

To evaluate the erosive conditions, profile lines were drawn along cross sections of the river in the middle of the area of interest and just downstream near the U.S.-160 bridge. The lines, shown in Figure 4-1 were used to plot the velocity profile along each cross section to visualize the changes in velocity for the existing conditions with 2018 LiDAR and the existing conditions with the post-2019 flood LiDAR.

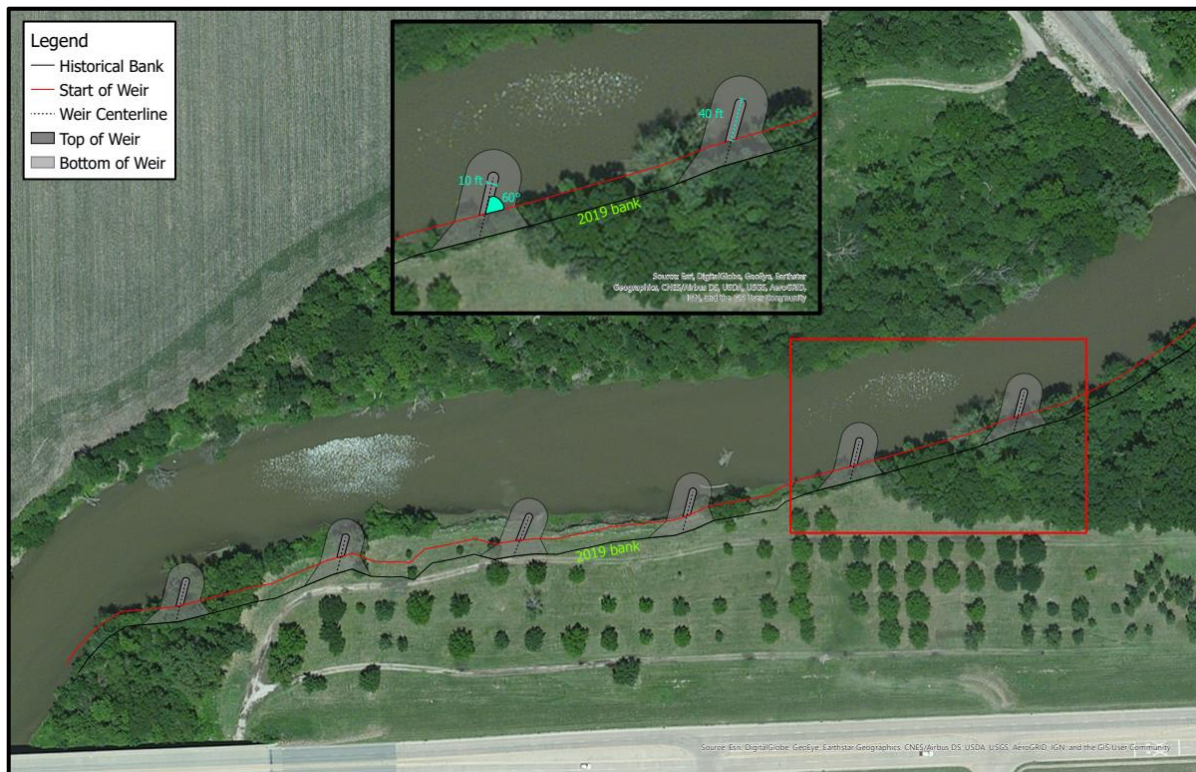
Figure 4-6: Overhead View of the Layout of Alternative 1

Alternative 1 consists of six bendway weirs installed 240 feet apart along the existing bank at an angle of 60°. The riprap would be installed with a slope of 1V:1.5H until an elevation of 14ft above the channel bed is reached, and then the weir would extend 40 feet further into the channel with a top width of 10 ft. A top view of the layout is shown in Figure 4-6 and a profile view of one of the weirs is shown in Figure 4-7.

The weirs would not be keyed into the existing ground, presenting some risk of failure. The bankline between the weirs would not be given any additional protection, leaving it more susceptible to continued erosion than Alternatives 2 and 3.

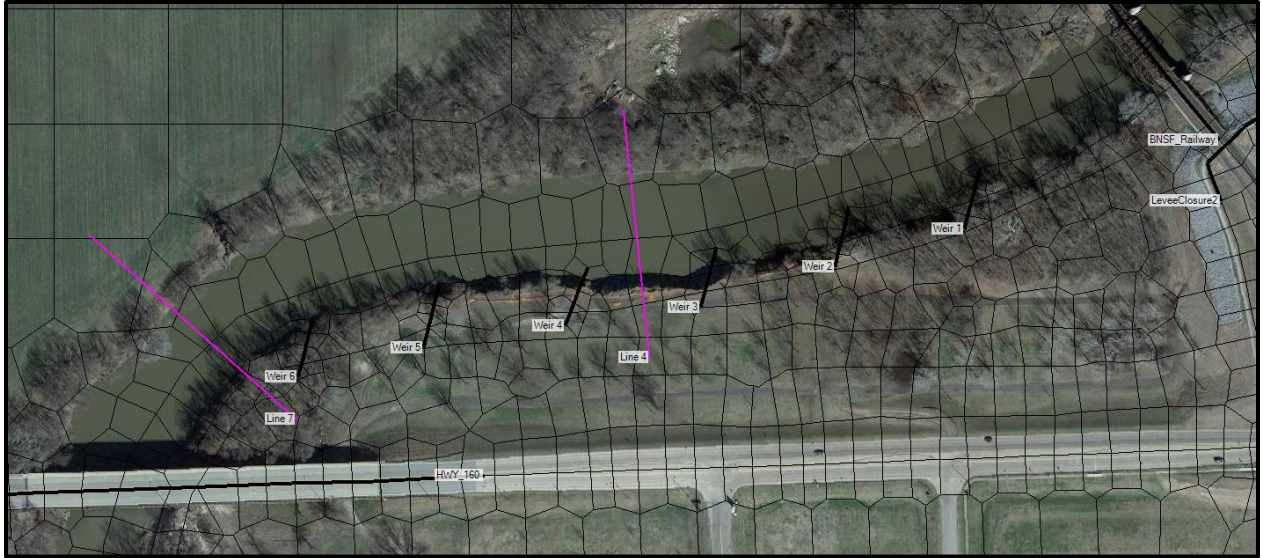
Figure 4-13: Locations of the Profile Lines Used to Evaluate the Change in Velocity Profiles

To evaluate the effects of the bendway weirs on the erosive conditions in the area of interest, profile lines were drawn along cross sections of the river in the middle of the bendway weirs and just downstream of the weirs near the U.S.-160 bridge. The lines, shown in Figure 4-13, were used to plot the velocity profile along each cross section to visualize the changes in velocity for the existing conditions with post-2019 flood LiDAR and Alternative 1.

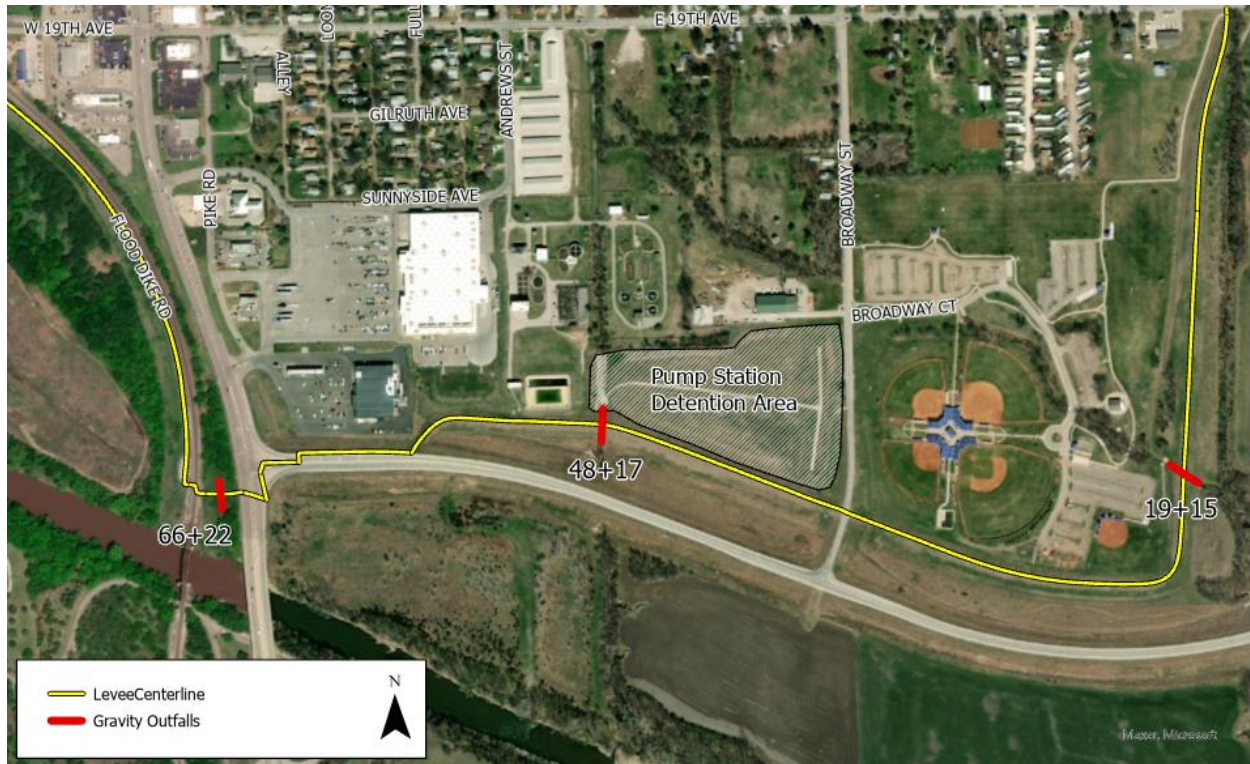
Figure 5-6: Pump station detention area adjacent to the levee.

Since the 1% annual chance interior floodplain did not result in flooding that cause much damage, a pump station would likely not show a positive benefit-cost ratio. The goal of the pump station was then shifted from reducing flooding risk to adjacent structures and instead looked at what size pump would be needed to pump down the storage area adjacent to the levee for an interior event that filled up this storage area but did not overtop Broadway Street to the East while the levee was closed, shown in Figure 5-6.

The 10yr interior rainfall event with a closed condition on the levee would fill up the storage area and come within a few tenths of a foot of overtopping Broadway. The volume needing to be pumped was approximately 95.8 acre-ft of water. The City agreed that a drawdown time of 7 days was reasonable for this area. A pump size of 3000 GPM would be needed to achieve this drawdown time.

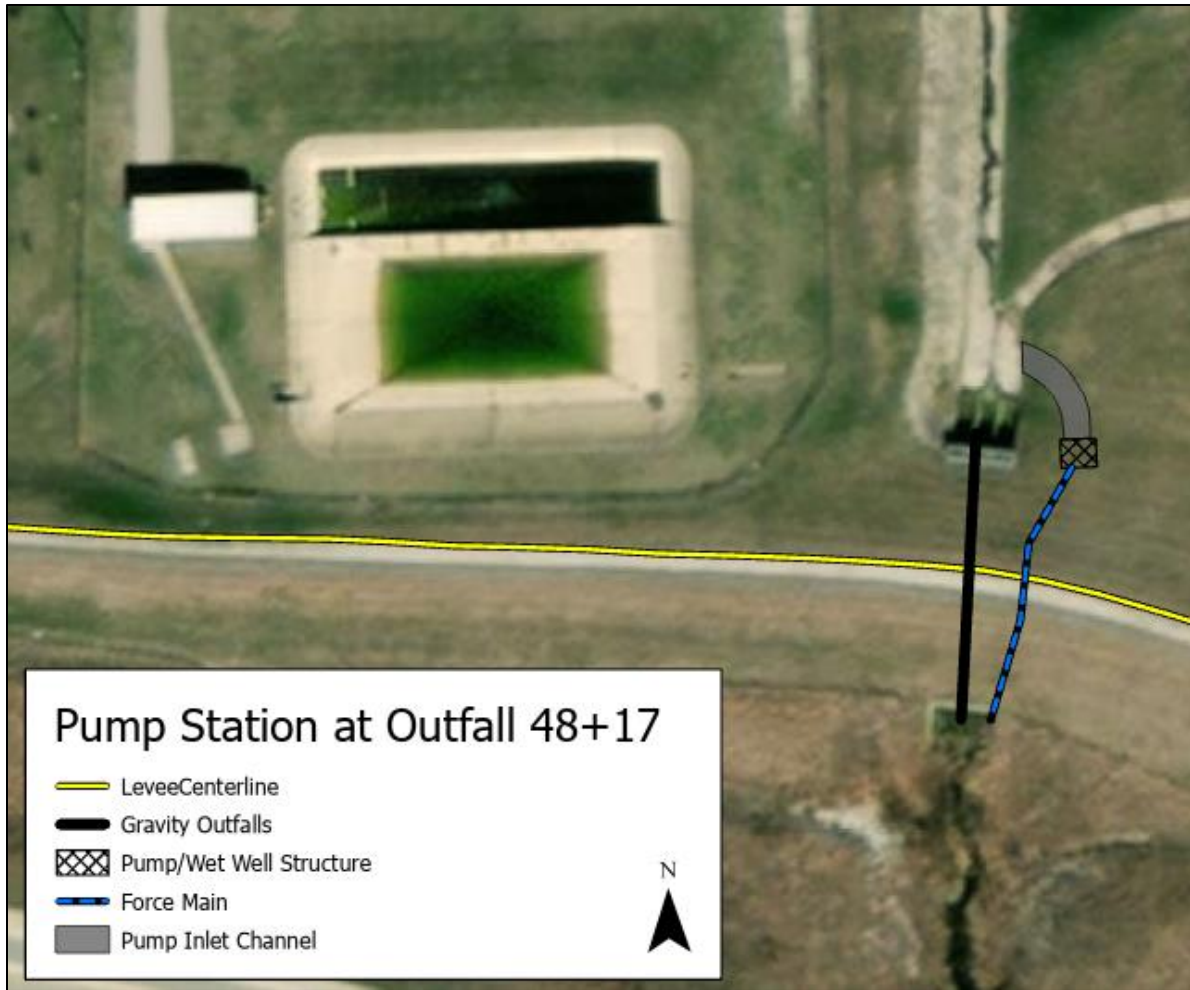
Figure 5-7: Pump Station layout at 48+17

Figure 5-7 shows the layout of the proposed pumpstation at levee outfall 48+17. A budget level cost estimate is tabulated in Table 5-2.

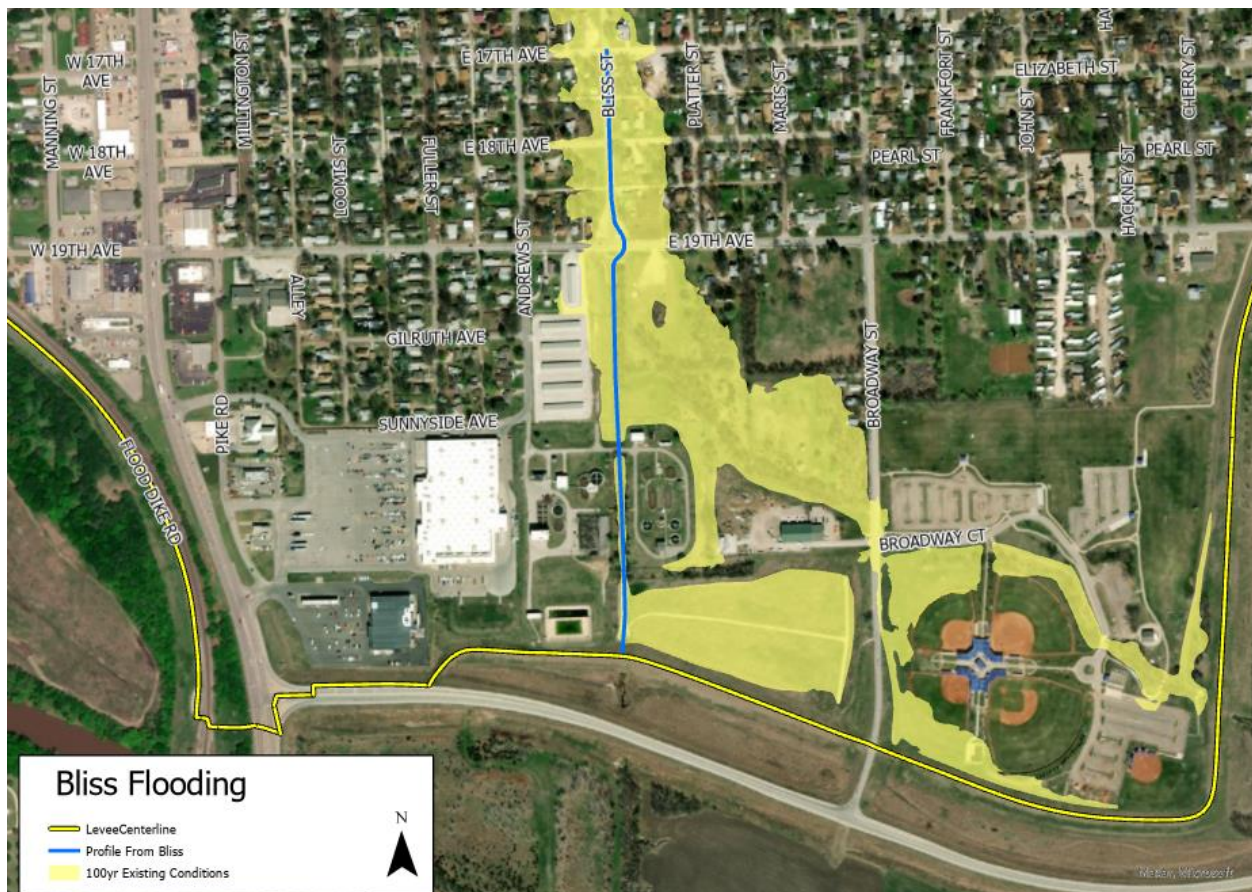
Figure 5-8: 1% annual chance rainfall with normal levee outfall conditions.

One of the issues prompting the need to evaluate adding a pump station to the levee was flooding concerns near Bliss Street and E 19th Avenue. Bliss Street is a lower street that acts as a conveyance for upstream water to get to the levee. Upon further analysis, it was discovered that an access road to the water treatment plant is not allowing enough water through it. This results in water backing up to Bliss and 19th. This flooding issue is shown in Figure 5-8.

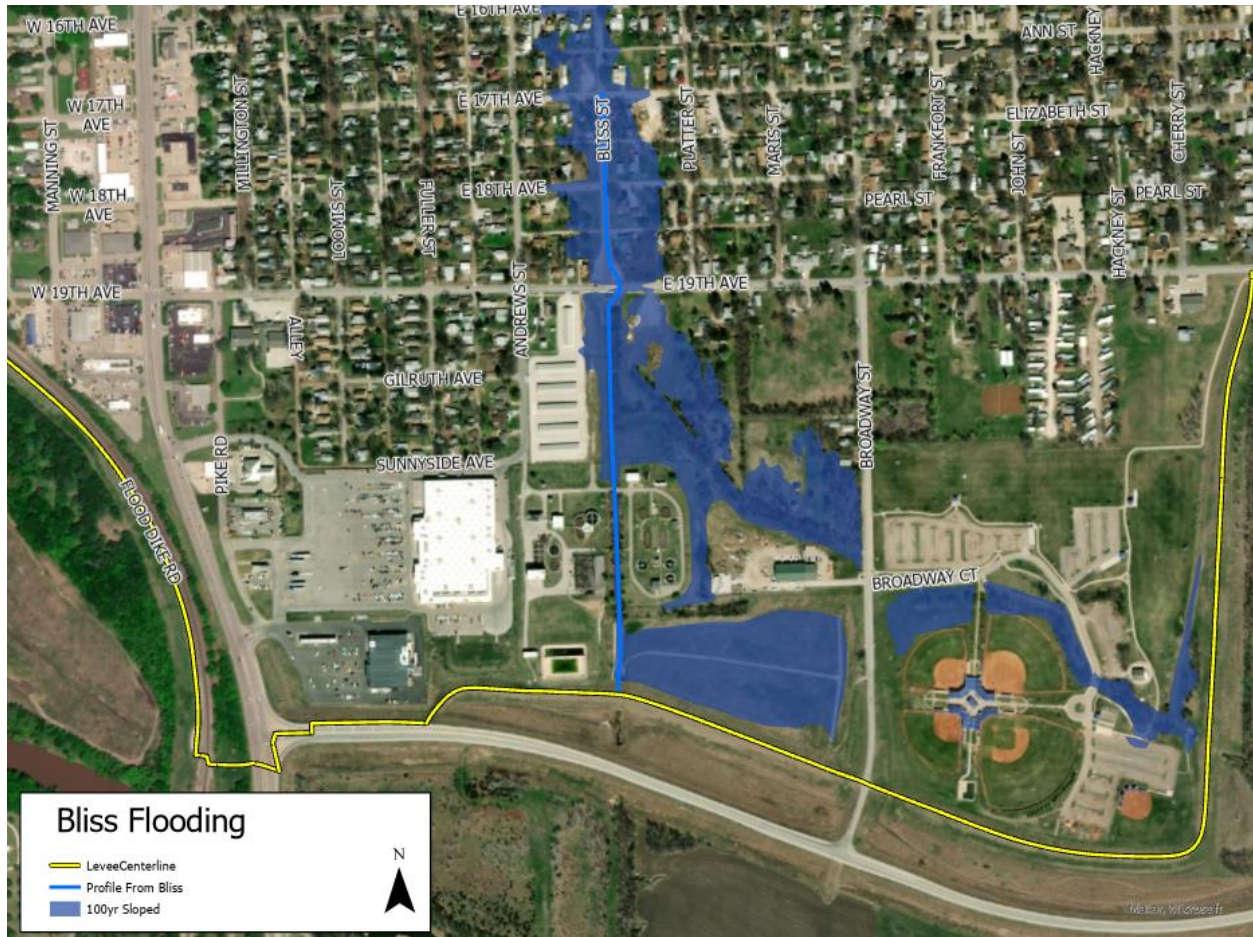
Figure 5-9: 1% annual change rainfall with normal levee outfall and increased slope from Bliss to the levee

A couple quick scenarios were simulated to evaluate how much this structure is causing water to back up to Bliss and 19th. First the channel from Bliss and 19th down to the levee was increased in slope while leaving the access road to the water treatment plant with the same sized pipe dimension. Shown in Figure 5-9 is the flooding associated to this first scenario.

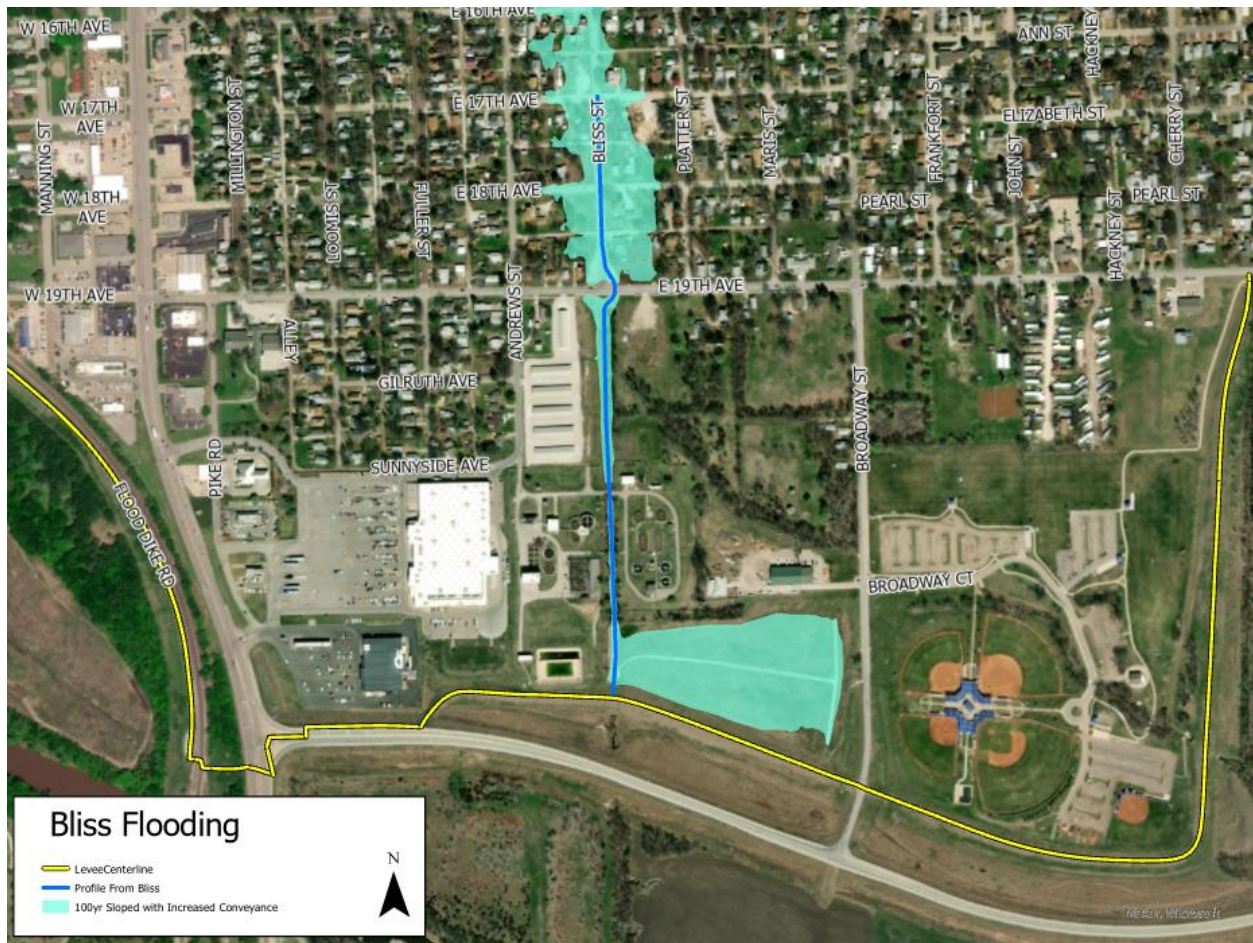
Figure 5-10: 1% annual chance rainfall with normal levee conditions and increased slope and conduit size between Bliss and the levee.

The second scenario tested was to increase the slope while also increasing the conduit size through the access road. The conduits through the access road were increased from 2-barrel 5.5' CMP to 3-barrel 8'x6.5' RCB. This size was selected to match the conduits that outflow through the levee system. This scenario is plotted in Figure 5-10.
